CHARTIERS CREEK-OHIO JUNCTION ACCESS SHAFT IMPROVEMENTS

ADDENDUM NO. 1

**ATTACHMENT C PETROGRAPH OBSERVATIONS AND IMAGES, ALCOSAN O-07
TUNNEL ACCESS STRUCTURE H244026**

RE: ALCOSAN O-07 Tunnel Access Structure H2440126
RJ Lee Group Project Number TCH011013

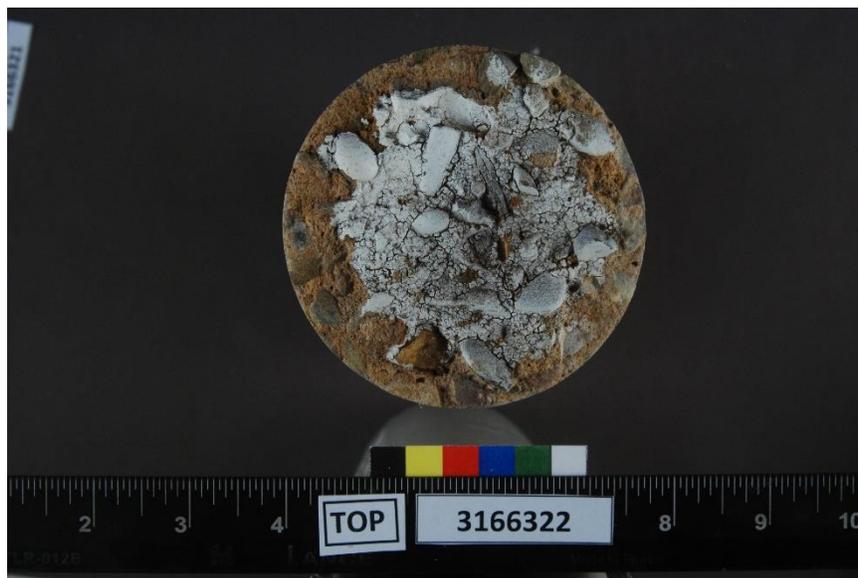
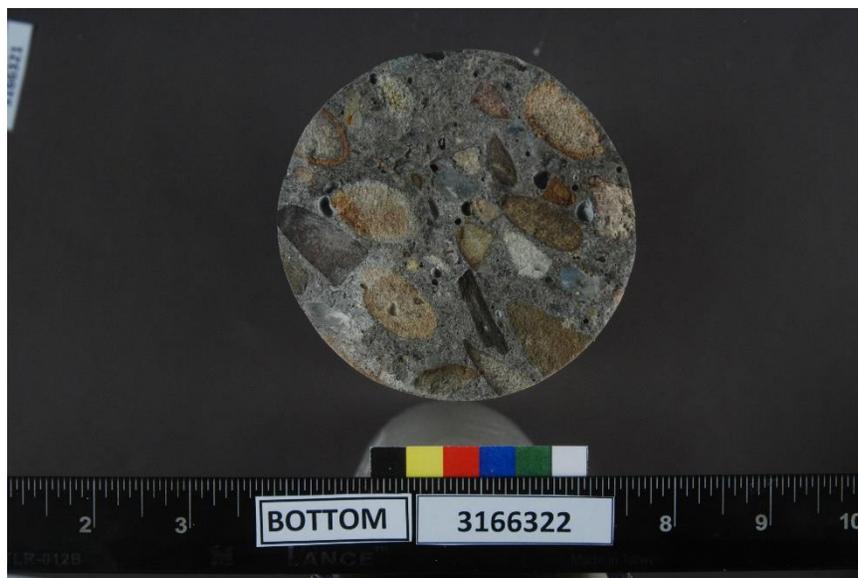
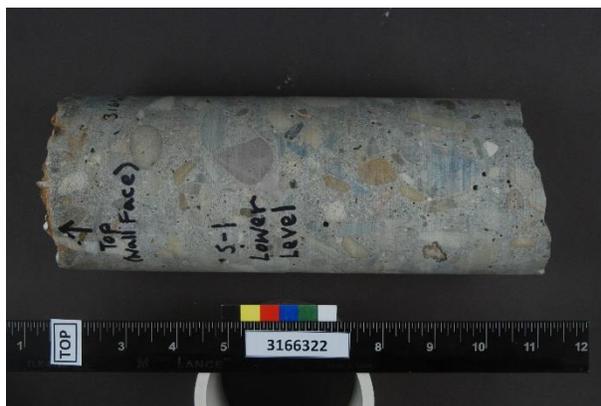
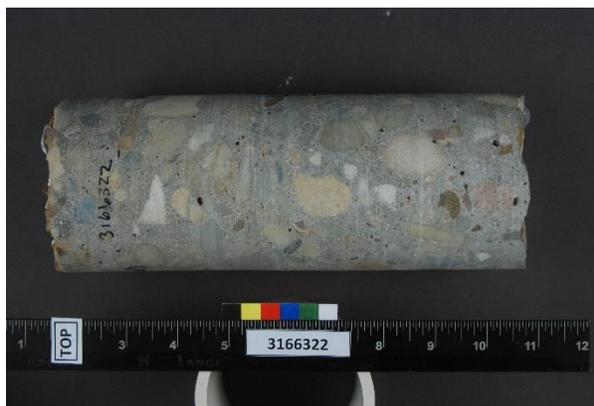
The top surface was moderately scaled up to $\frac{3}{8}$ " deep with soft, orange discolored paste and exposed coarse aggregate. A thin layer (50 μ m) of gypsum was deposited on the surface. The top $\frac{3}{8}$ " paste was soft and de-calcified with elevated iron and phosphorous. Localized sub-parallel microcracks were present in the altered paste. A layer of gypsum was present in the altered paste approximately $\frac{1}{4}$ " deep. Minor amounts of thaumasite was observed lining and filling voids up to $\frac{1}{2}$ " deep. Severe amount of secondary ettringite deposits in the paste and filling voids was present up to $\frac{3}{8}$ ", then in moderate amounts up to $1 \frac{1}{4}$ " deep. Together, these observations indicate that the top $\frac{1}{2}$ " has been damaged by severe external sulfate attack.

Figure 1. Lower level S-1 (3166322). Photographs of core in as-received condition.

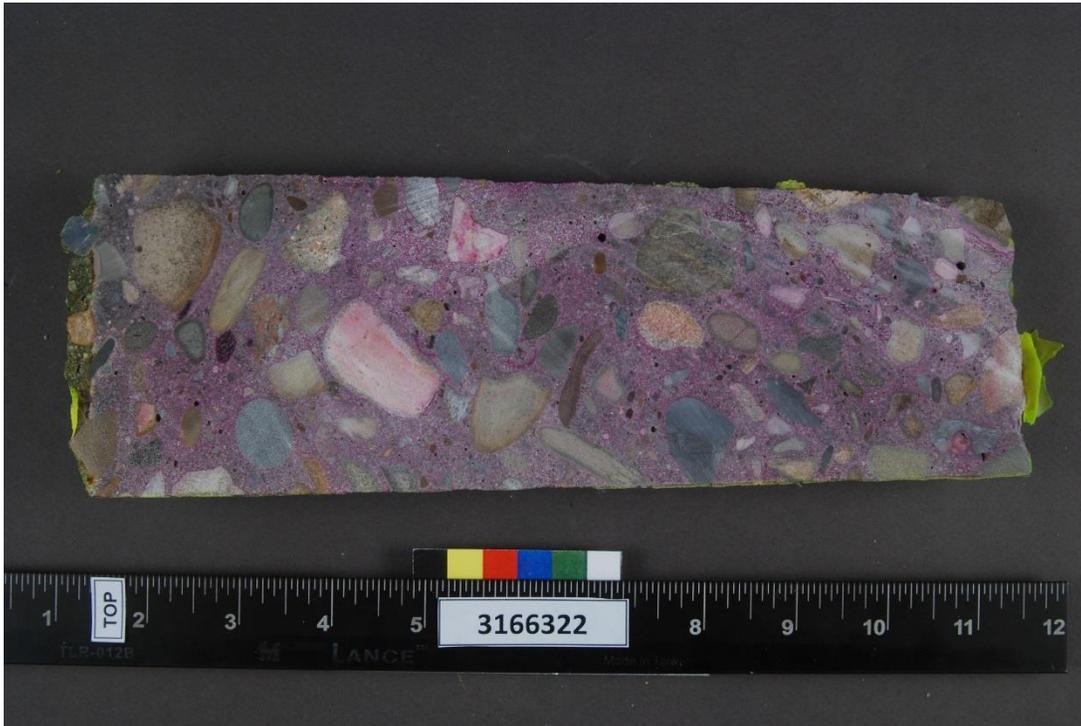
Figure 2. Lower level S-1 (3166322). Photograph of freshly cut surface with phenolphthalein indicator applied. The surface of the core was coated with fluorescent dyed epoxy before cutting.

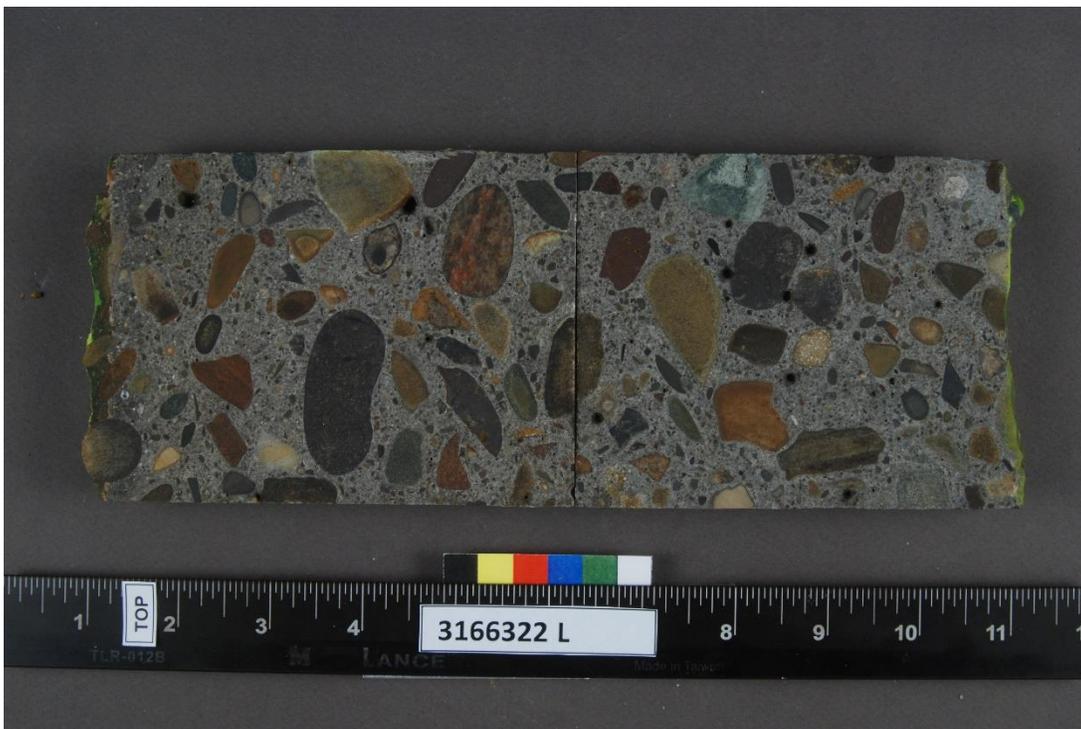
Figure 3. Lower level S-1 (3166322). Photograph of polished cross sectioned slab. The surface of the core was coated with fluorescent dyed epoxy before cutting.

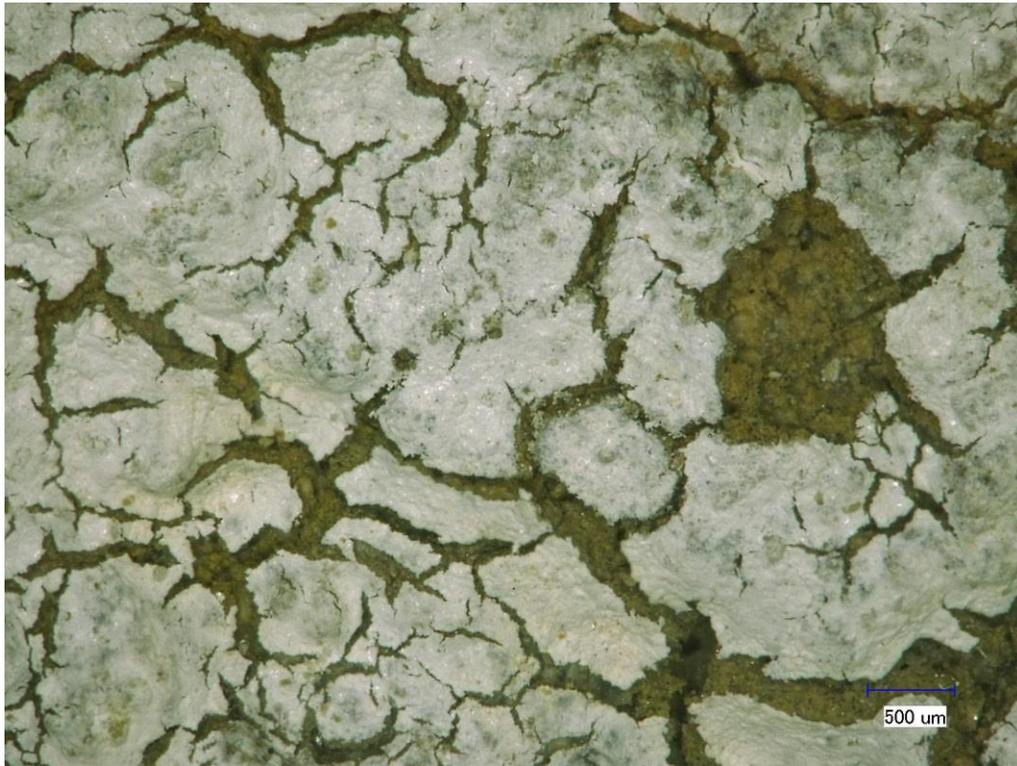
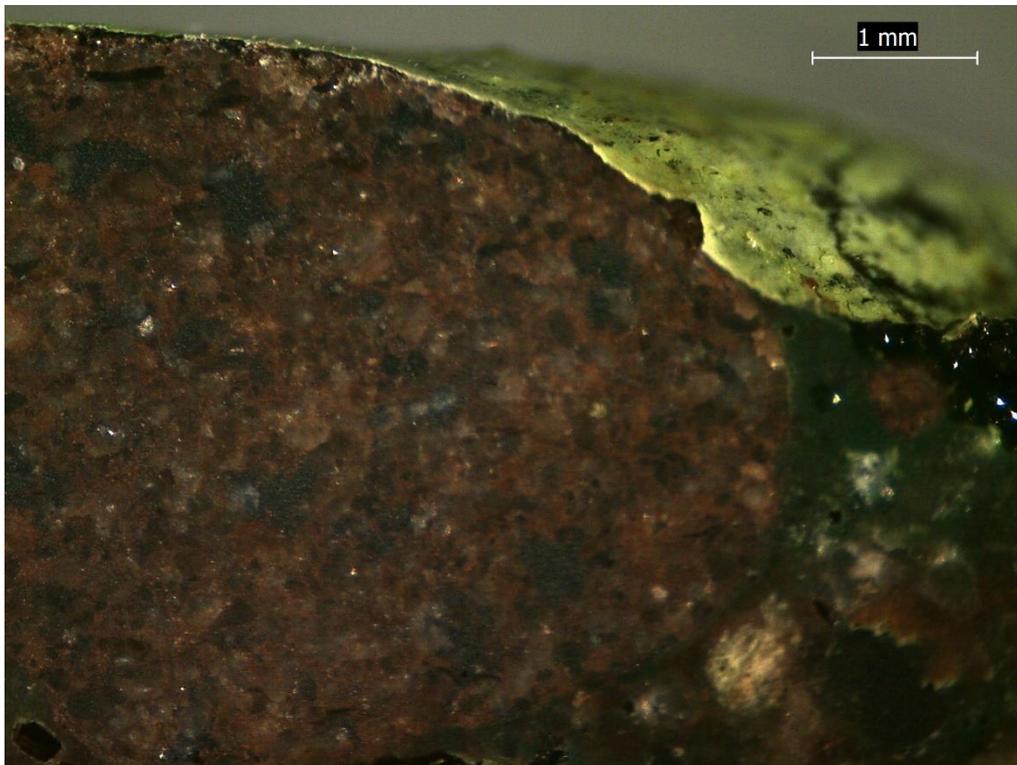
Figure 4. Lower level S-1 (3166322). Stereo-optical micrographs showing a cracked, white desposit on the surface.

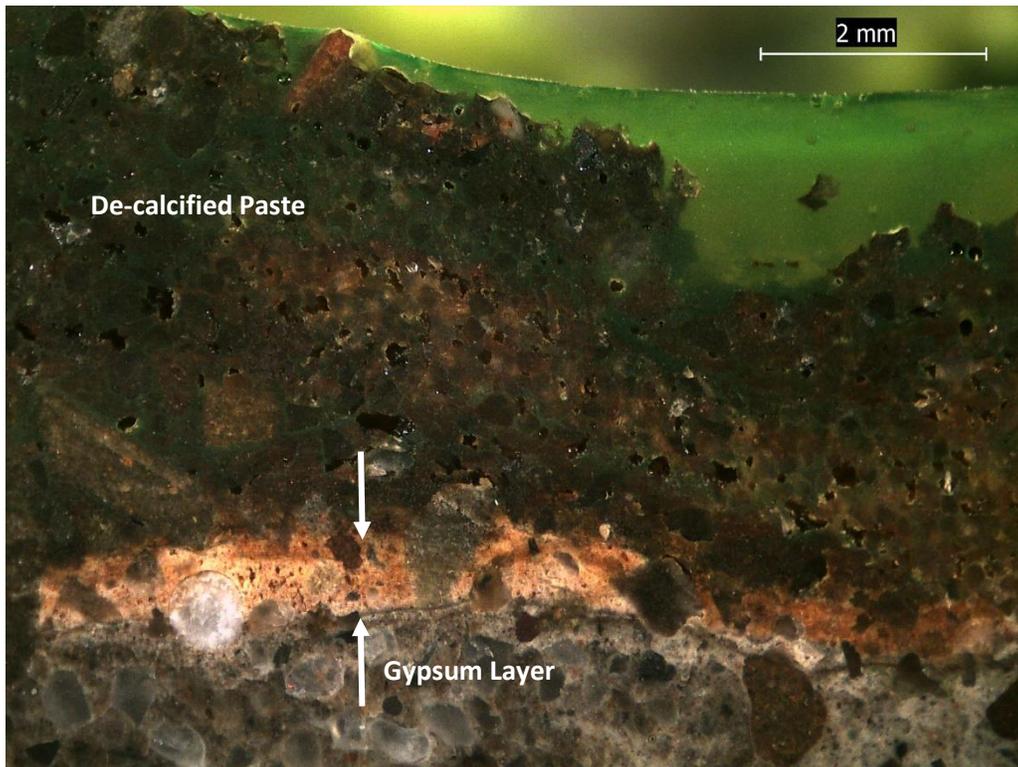
Figure 5. Lower level S-1 (3166322). Stereo-optical micrographs showing porous, de-calcified paste along the surface and a layer of gypsum desposits highlighted by the two arrows.

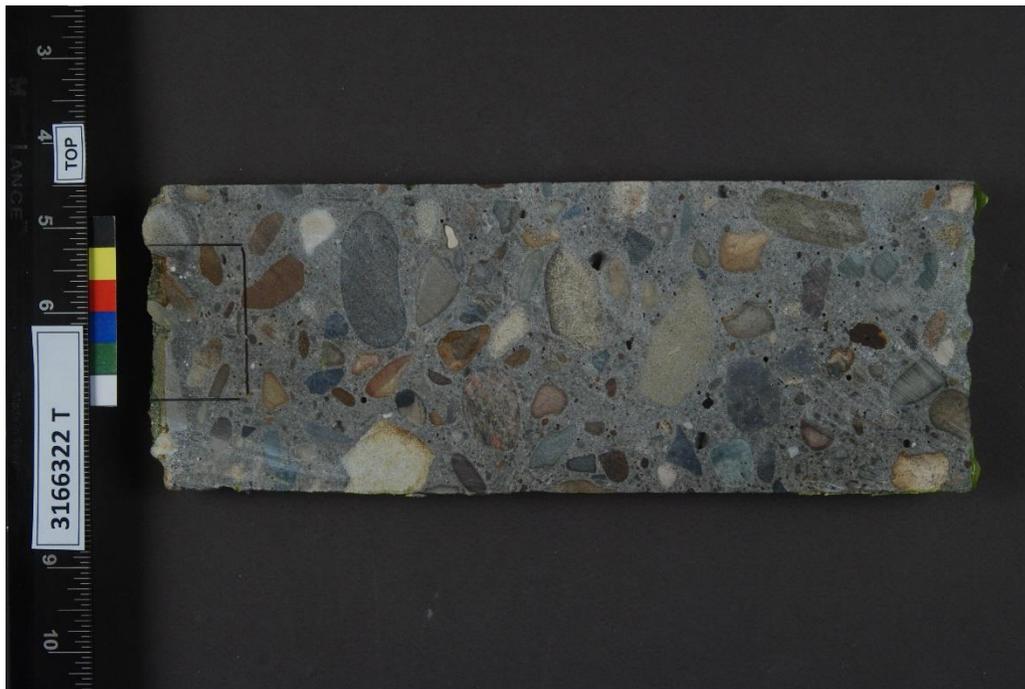
Figure 6. Lower level S-1 (3166322). Photograph of cross sectioned slab showing location of thin section preparation outlined in black.

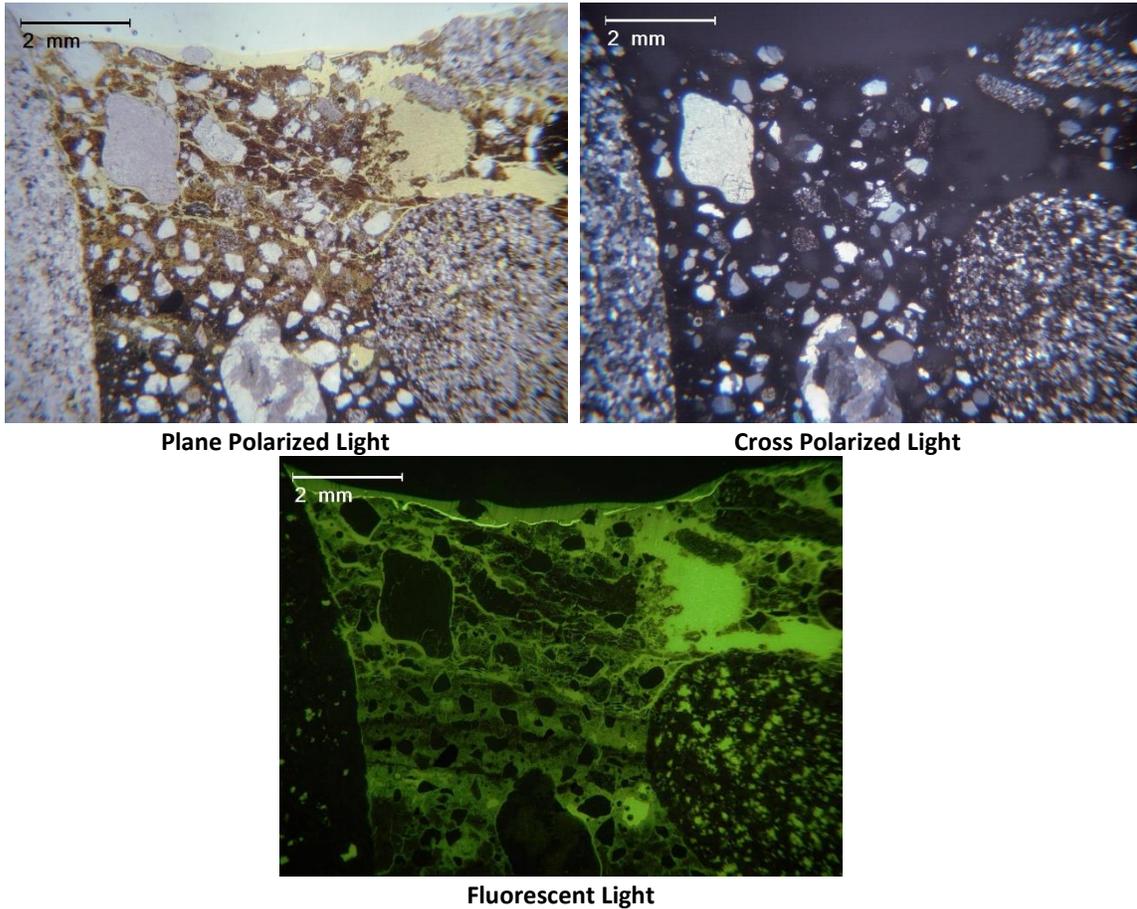
Figure 7. Lower level S-1 (3166322). Micrographs of the near surface in thin section showing sub-parallel microcracks in the iron-rich de-calcified paste in different light modes.

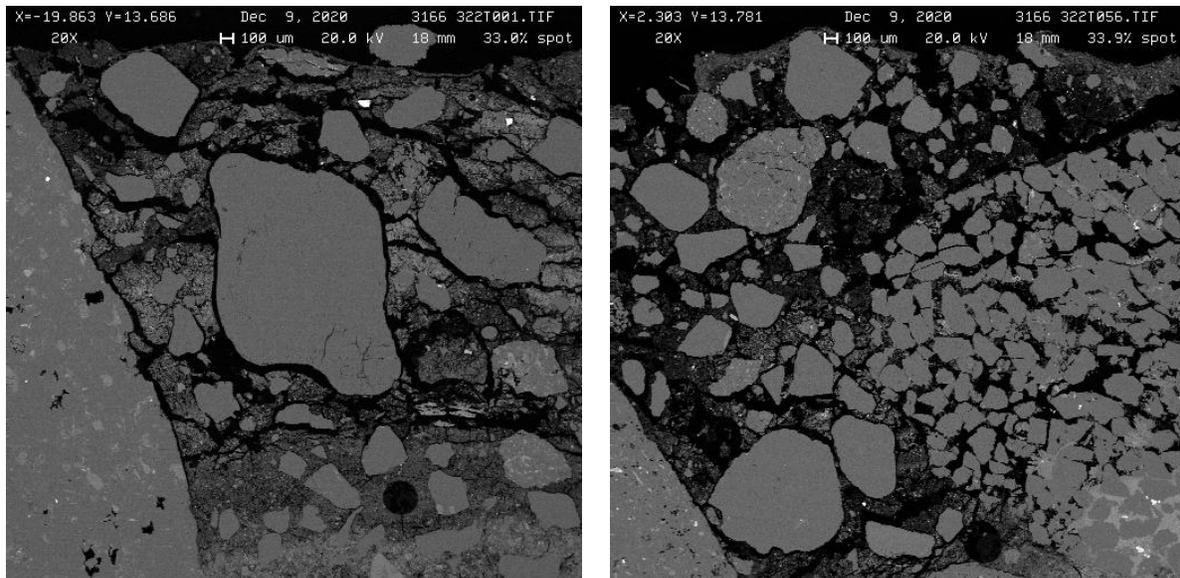
Figure 8. Lower level S-1 (3166322). Backscattered electron images showing the de-calcified, leached paste at up to 3/8" deep. Sub-parallel microcracks are present in the left-hand image.

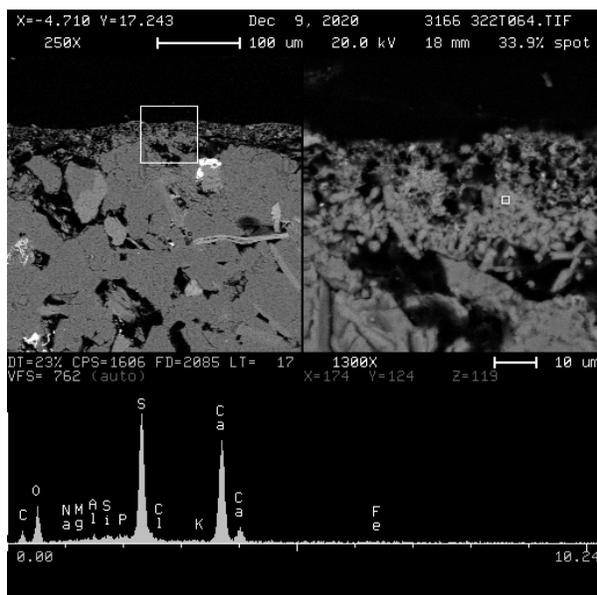
Figure 9. Lower level S-1 (3166322). BSE images with EDS spectrum of gypsum coating on an exposed coarse aggregate.

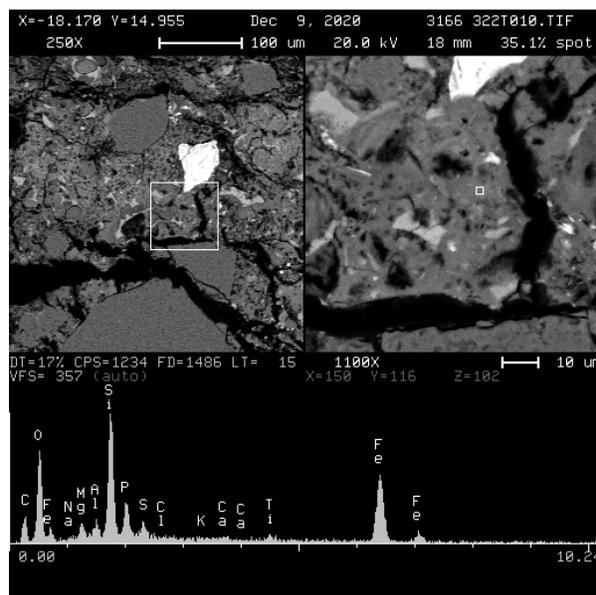
Figure 10. Lower level S-1 (3166322). BSE images with EDS spectrum of iron-rich de-calcified paste with minor phosphorous.

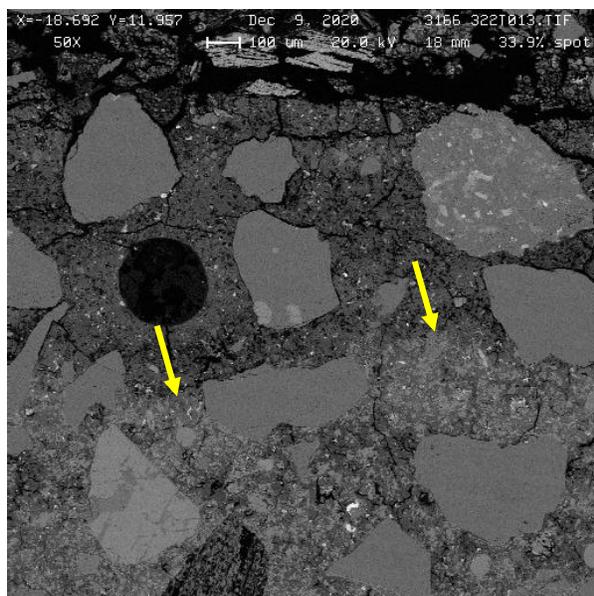
Figure 11. Lower level S-1 (3166322). BSE image showing the gypsum in the paste (in area highlighted by the arrows).

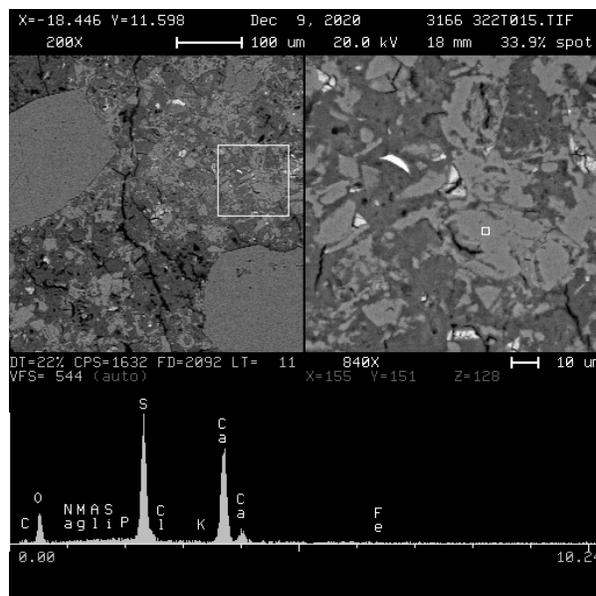
Figure 12. Lower level S-1 (3166322). BSE images with EDS spectrum of gypsum in the de-calcified paste.

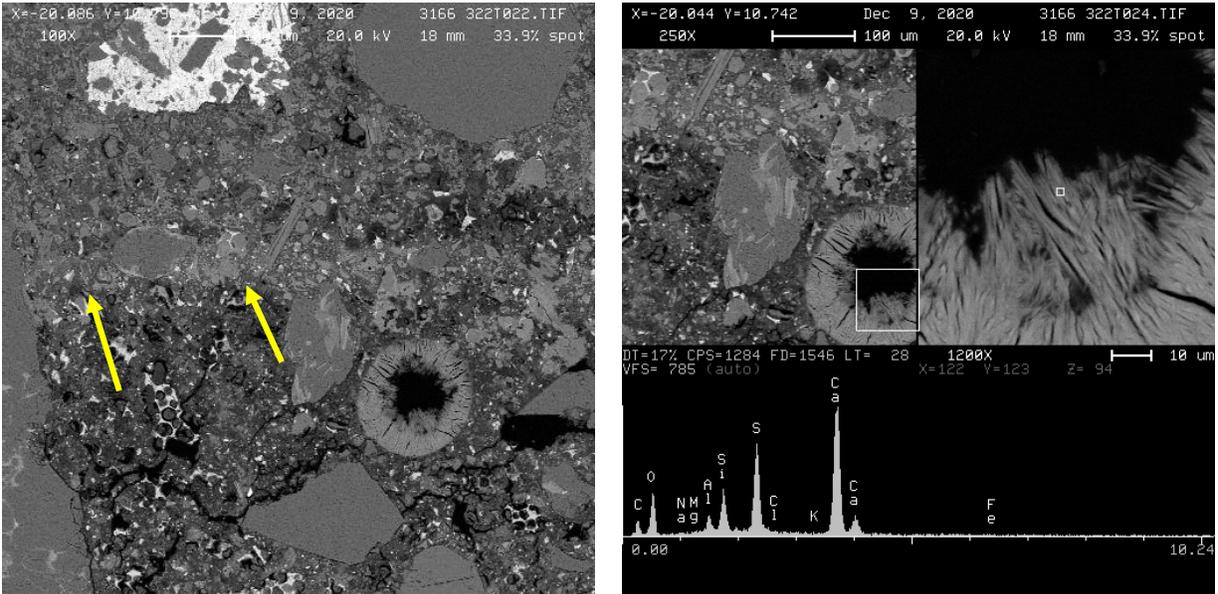
Figure 13. Lower level S-1 (3166322). BSE images with EDS spectrum of thaumasite lining a void below the gypsum front (in area highlighted by the arrows).

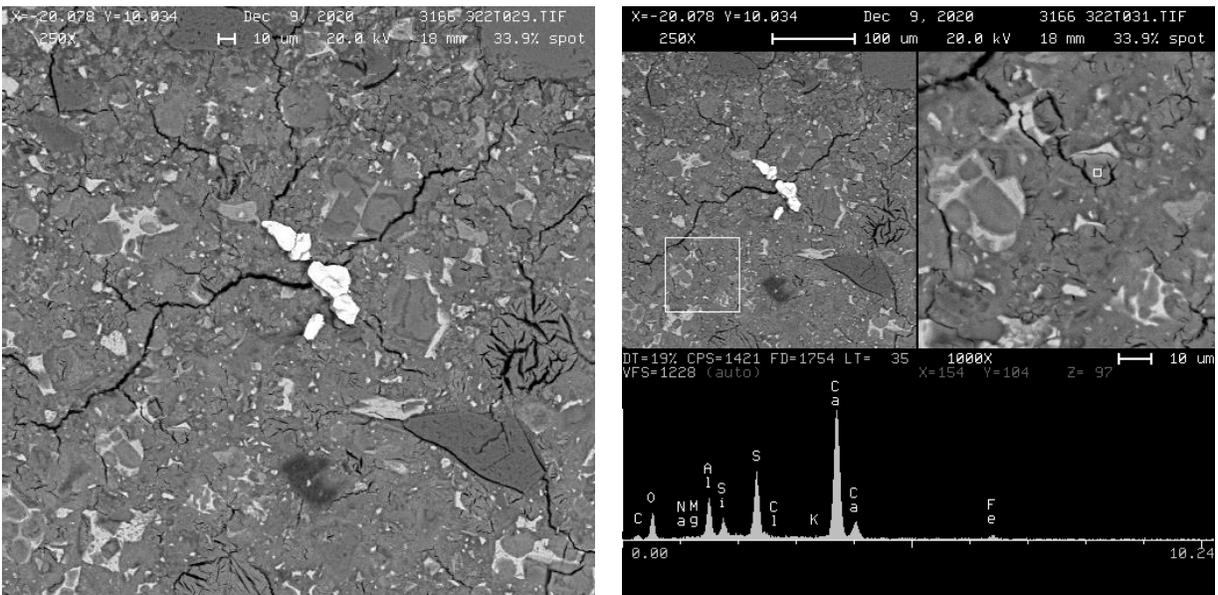
Figure 14. Lower level S-1 (3166322). BSE images with EDS spectrum of severe amounts of secondary ettringite deposits in the paste at approximately 1/4" deep.

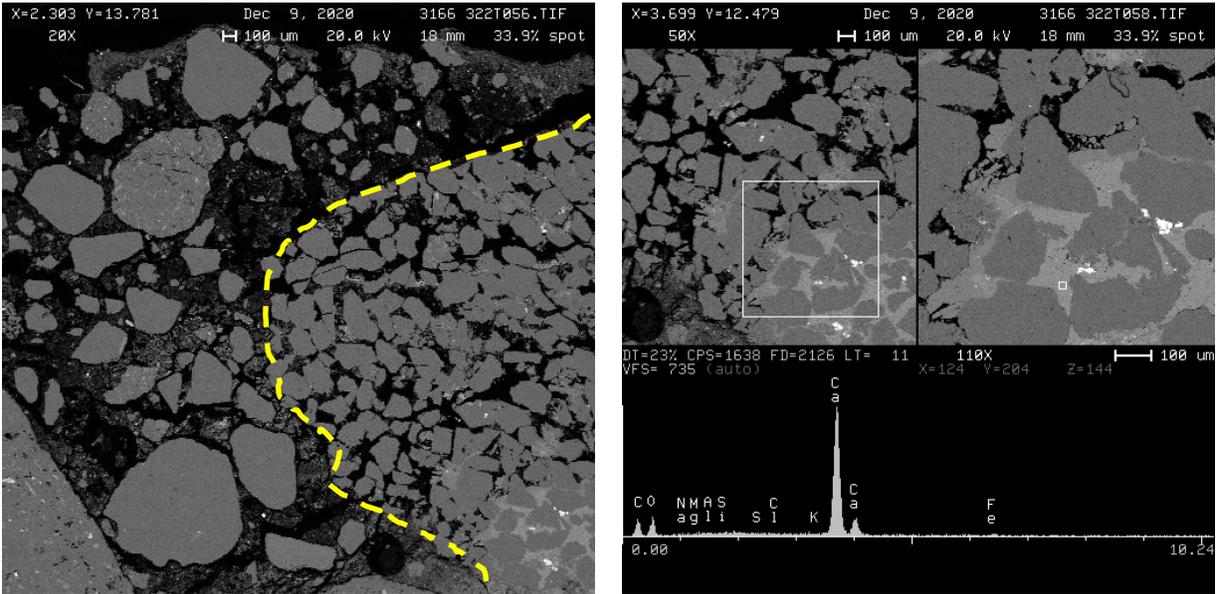
Figure 15. Lower level S-1 (3166322). BSE images with EDS spectrum showing the loss of calcium binder in the siliceous sandstone coarse aggregate (outlined by dashed line).

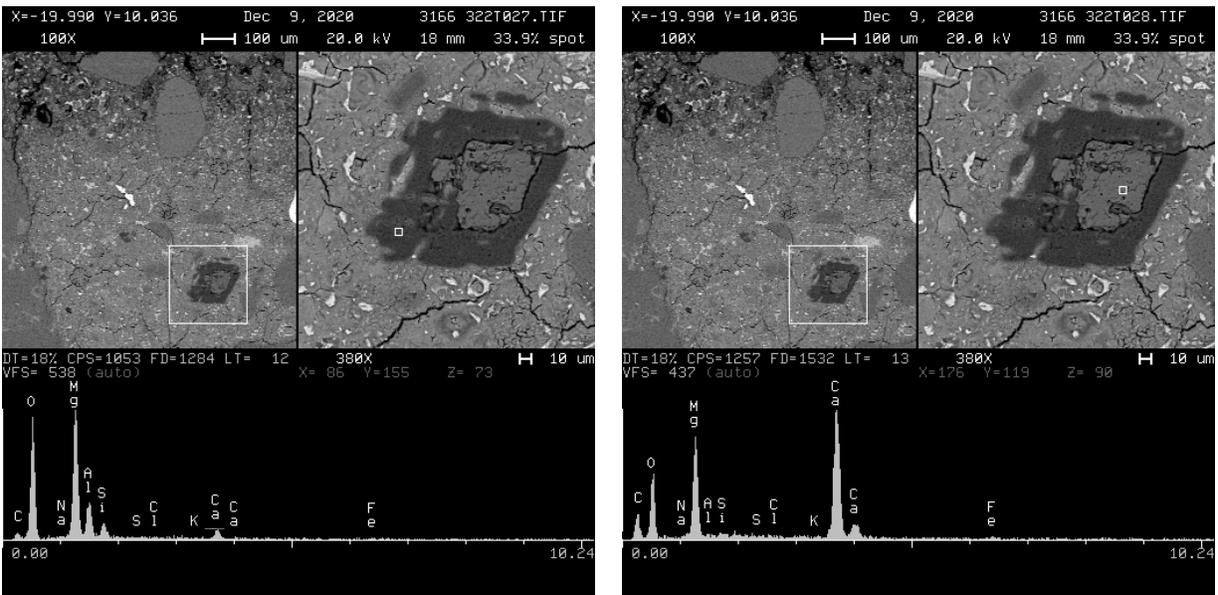
Figure 16. Lower level S-1 (3166322). BSE images with EDS spectra showing de-dolomitization of a dolomitic sand grain.

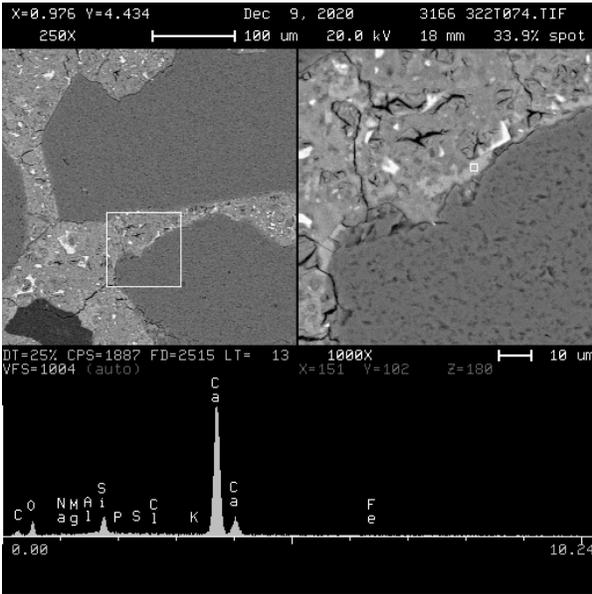
Figure 17. Lower level S-1 (3166322). BSE images with EDS spectrum of calcium hydroxide along the paste/aggregate interface at 1/2" deep.

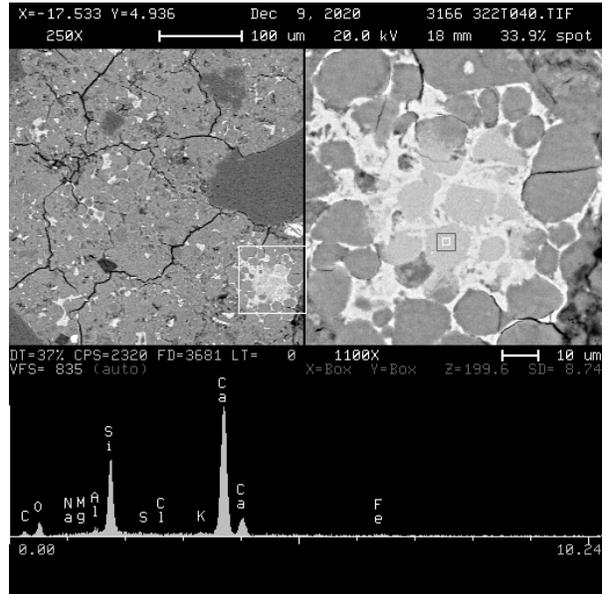
Figure 18. Lower level S-1 (3166322). BSE images with EDS spectrum of partially hydrated cement grain.
