Starting at the Source:
How Our Region Can Work Together for Clean Water

Appendix H - Project Location Site Summaries

Appendix E-8 – Project Location Site Summaries

Green Stormwater Infrastructure Field Evaluation (Part 1)

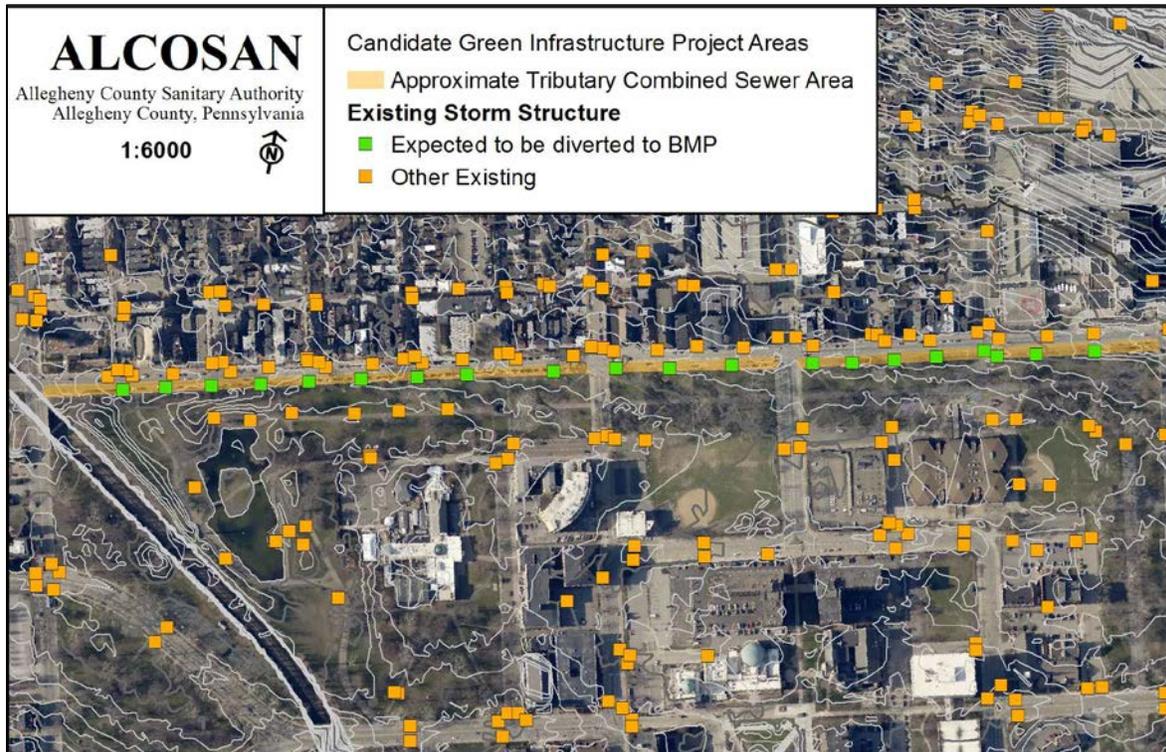
Potential Green Infrastructure Project Site
Site 32 - North Avenue along Allegheny Commons
City of Pittsburgh, Allegheny Center Neighborhood

Impervious area drains to a number of catch basins along North Ave. All basins appear to be well maintained. There are some portions of the sidewalk that are damaged and can be repaired as part of a GI project.

The curb is in good condition. The curb east of Federal St has a shorter reveal than the rest of North Ave.

Opportunity for GI along sidewalk within Allegheny Commons Park. A regrading of the sidewalk and park space may be necessary to allow runoff into GI. Numerous pedestrian entrances along North Ave could be attractive locations to create a more welcoming entrance to the park. An infiltration trench or bioretention area within the park could be connected to a nearby catch basin and serve to capture runoff. Mature trees are present in close proximity to the sidewalk and siting of GI would need to accommodate existing trees.

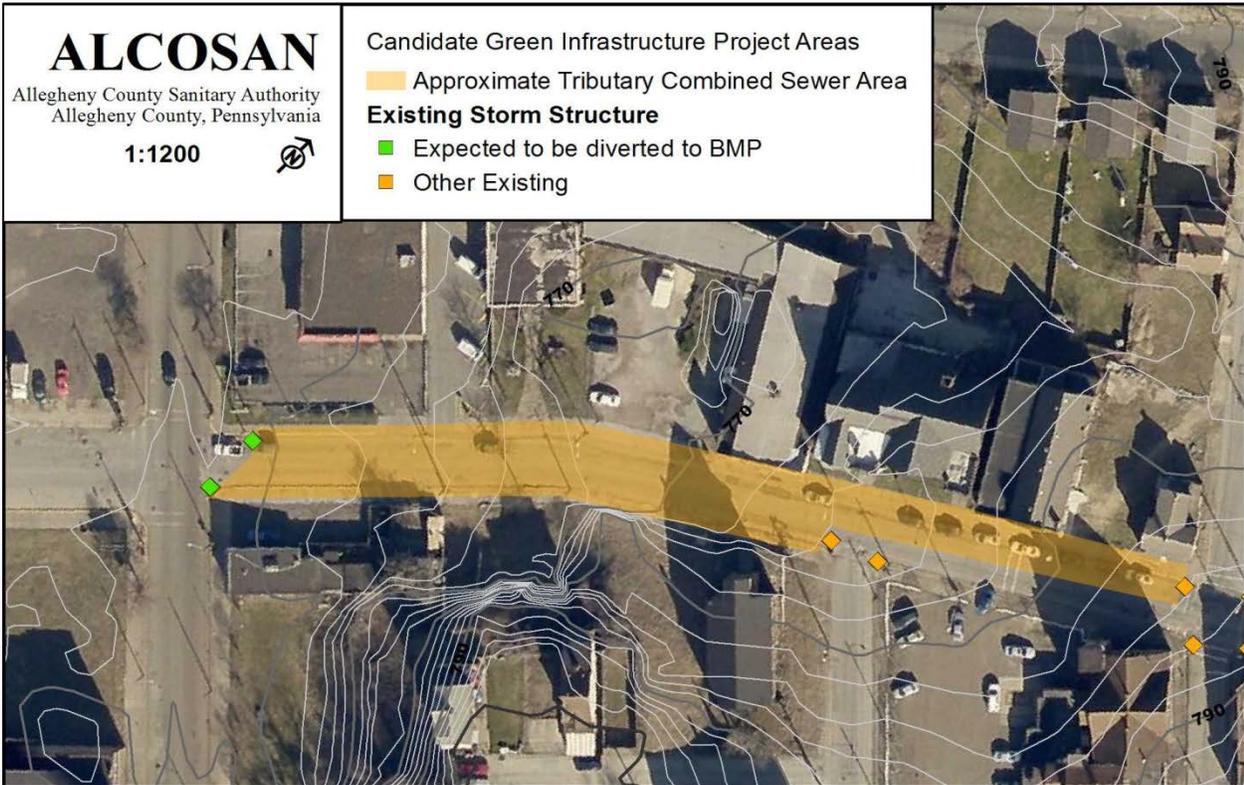
Potential Green Infrastructure Project Site
Site 2 - 6th Street intersection
Braddock Borough

The curb is in poor condition. The sidewalk is cracked and the curb has a low reveal.

Opportunity to place GI upstream of catch basins on Braddock Ave. Public ROW on corners could allow sufficient space to site GI and capture runoff. Another potential location is adjacent to an open overgrown area along 6th across from the Braddock Municipal Building. There is potential to construct an infiltration trench with a curb cut to capture runoff flowing down 6th west of Lillie Ave.

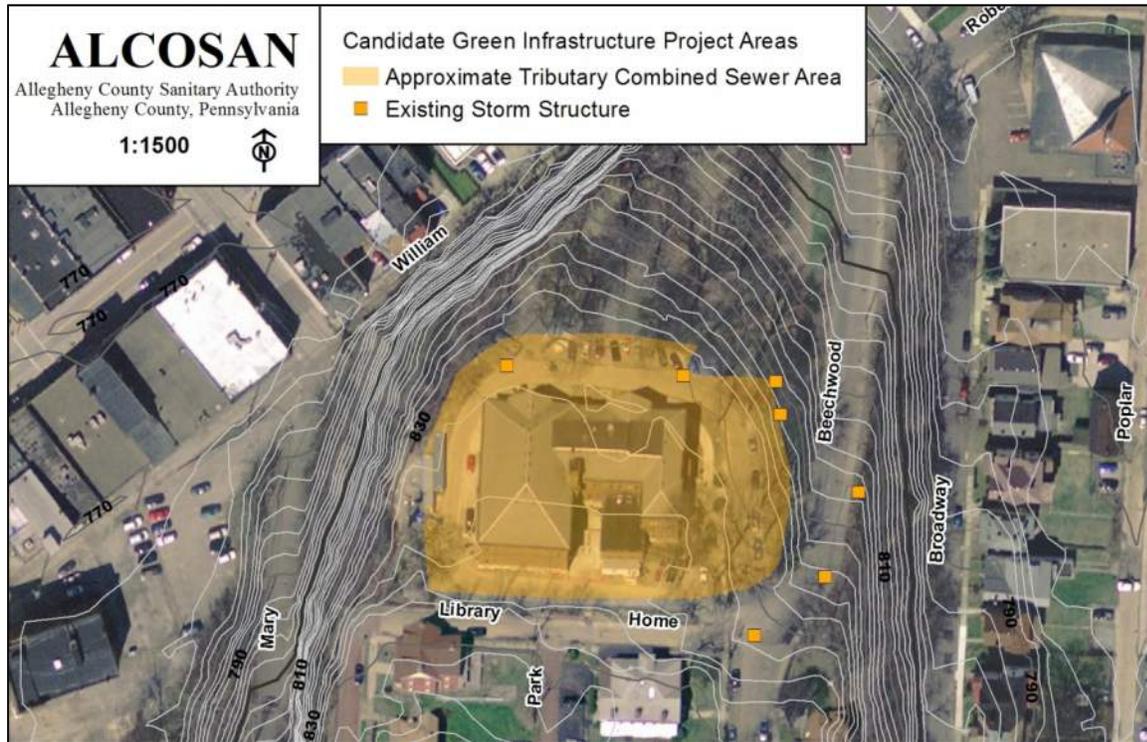
Potential Green Infrastructure Project Site
Site 74 - Carnegie Library and Music Hall
300 Beechwood Ave, Carnegie, PA

There are 4 inlets located at the North end of the property that capture runoff from the library driveway and parking spaces. Much of the existing parking is a hard packed gravel surface with additional gravel around much of the perimeter of the building. There may be a French drain configuration along the building perimeter as there are two storm pipes which appear to be coming from the library property and drain onto Beechwood Ave. These storm drains are 8" and 6" in diameter. Additional catch basins along Beechwood Ave capturing runoff running down the hill are noted on the map, these catch basins could be modified to take additional runoff from surrounding streets and into GSI installed in ROW adjacent to library property.

Smaller asphalt berms are used to direct flow toward on site inlets. Curbs along Beechwood Ave, Home St and Library Ave are in good condition. Some sediment build-up along Library Ave.

It appears some flow from parking area flows over the green space down the hill. Sediment buildup at corner of Home St and Library Ave observed. May be limited space to adequately manage runoff from Beechwood due to slope.

Existing stormwater management plans on site must be obtained from library. Potential areas to include GSI in the parking lot and surrounding driveway, enhancing existing landscaping to manage stormwater via disconnection of downspouts, and the potential for swales along the ROW of Beechwood Ave and Home Street. Opportunities for a porous pavement parking lot exist if desired, but existing gravel drainage offers some infiltration. Modification of on site inlet structures and curb grading may be necessary. Opportunity to work with Carnegie Library system to educate community about GSI in Carnegie.

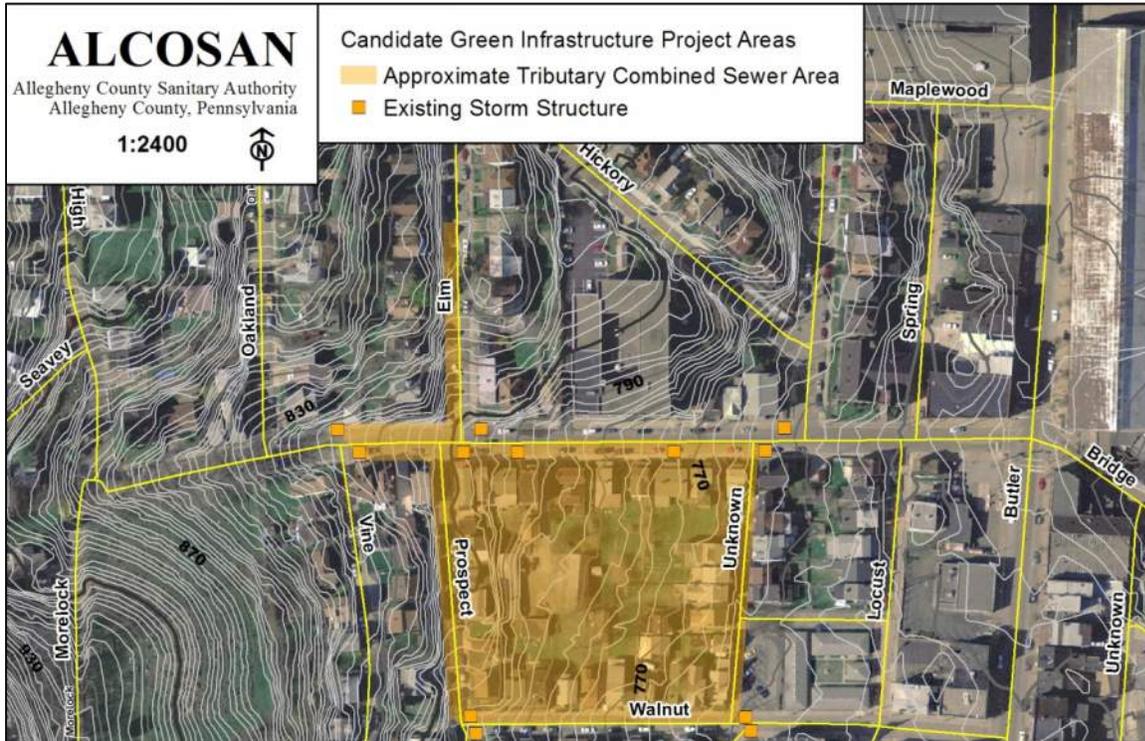
Potential Green Infrastructure Project Site
Site 106 - Walnut Street Block Etna 225
Etna Borough

| There are 6 catch basins which define the sewershed surrounding the four streets assessed. This sewershed appears consistent with Etna's report. However, runoff from Elm and an additional block of High Street may enter this sewershed based on what was observed in field. All inlets are well maintained. | | |

Surrounding area is residential with a nearby church and a funeral home. Potential conflict with street parking as there is a narrow ROW and no observed driveways or garages, only residential on-street parking. It was difficult to conceptualize where in the ROW of Walnut Street GSI could fit based on the existing land use.

Current width of ROW on Walnut, Prospect and School Streets appears to make GSI retrofits difficult. Potential to place infiltration/bioretention bumpouts on Walnut street if Borough willing to eliminate street parking spaces. Potential to use porous pavement in existing parking lanes as a potential technology as well. The ability to repurpose parking for GSI or potential for porous paving would need to be discussed with the borough.

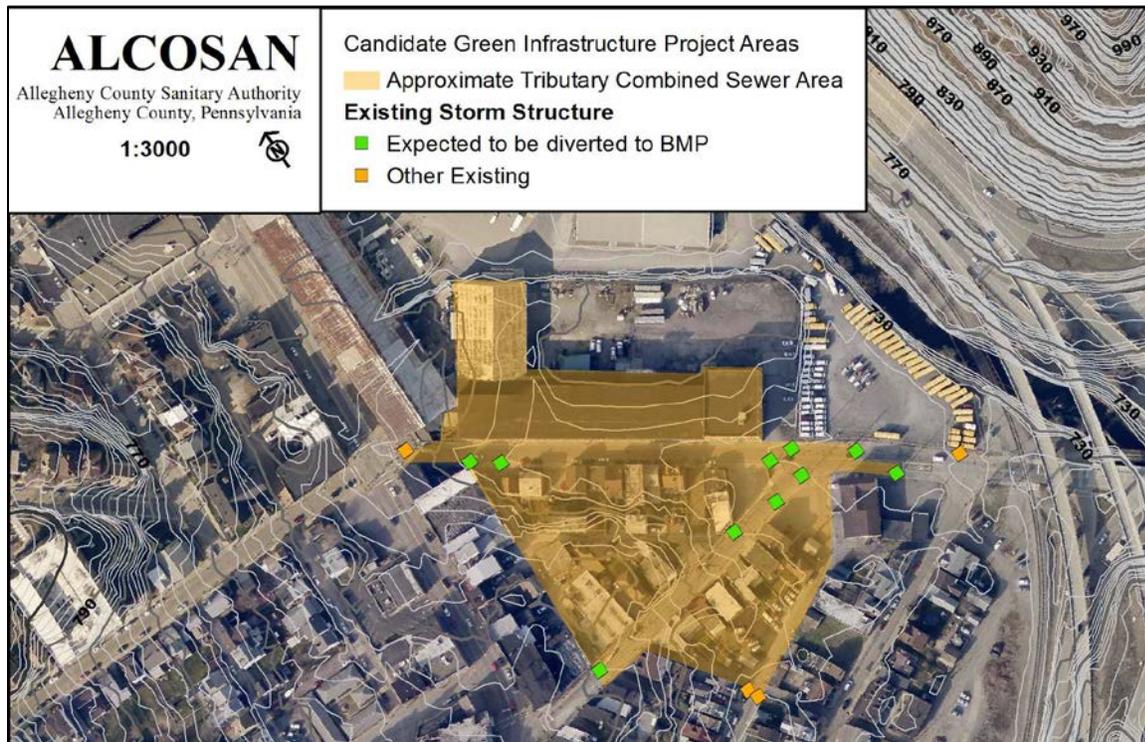
Potential Green Infrastructure Project Site
Site 104, 107, 108 - Bridge Street Block Etna 056, 056A, 057
Etna Borough

The curb was low and/or deteriorated along many streets in the area of interest.

There is limited space within the area to site GI projects. The Welcome to Etna sign at the corner of Bridge and Freeport could be the center piece of a GI installation. A rain garden may be able to be sited at this location and the Etna sign could be more vibrant with the addition of GI. Another gravel lot inbetween Strawberry and Freeport appears to be underused. Underground storage facility could potentially be implemented. The adjacent land owner would need to be contacted in both cases. The 057 building is a prime candidate for downspout disconnection. A more ambitious goal would be to restore some of the riparian buffer along pine creek and use GI as a polishing step before flowing into the creek.

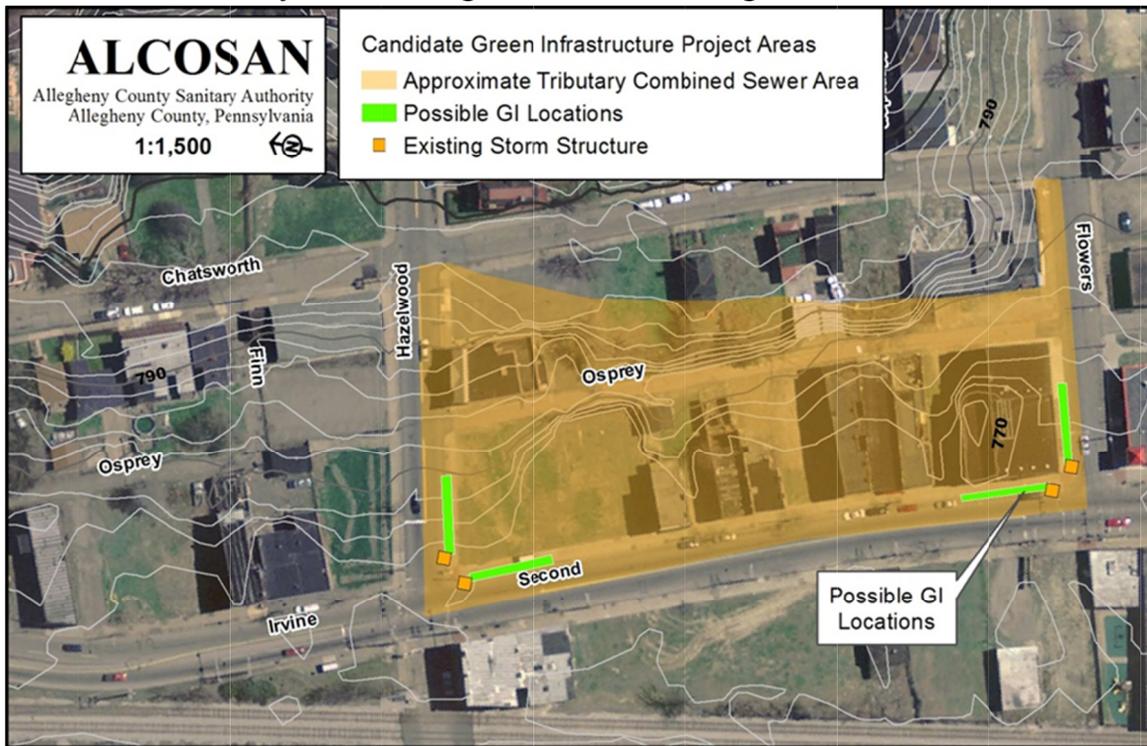
**Potential Green Infrastructure Project Site
Site 5 - 4800 Block of 2nd Avenue Redevelopment
City of Pittsburgh, Hazelwood Neighborhood**

Curb Condition
 Generally good condition along 2nd Ave., western side has lower curb due to paving build-up. Osprey Way has poor curbing and areas of no curb along parts adjacent to 4800 block parcels. Northern side of Flowers Ave has lower curb due to paving. Curbs on both sides of Hazelwood seem to be in good condition.

Building Downspout Connection (Which buildings appear connected? Mark connected roofs on aerial maps)
 Building 4847 on the corner of Flowers and 2nd has three external downspouts two of which have been stolen/broken. Building on corner of Hazelwood and Osprey has two external broken downspouts. See photos.

Placing GSI upstream of each of 4 catch basins in delineated area. GSI applications could include curb cuts to either swales or street tree bioretention along 2nd Ave, Hazelwood Ave and Flowers Ave. Osprey Way is an existing brick street, whether this will be reset as part of redevelopment needs to be determined; potential exists to have this alley allow for infiltration with subsurface storage (i.e. a green alley).

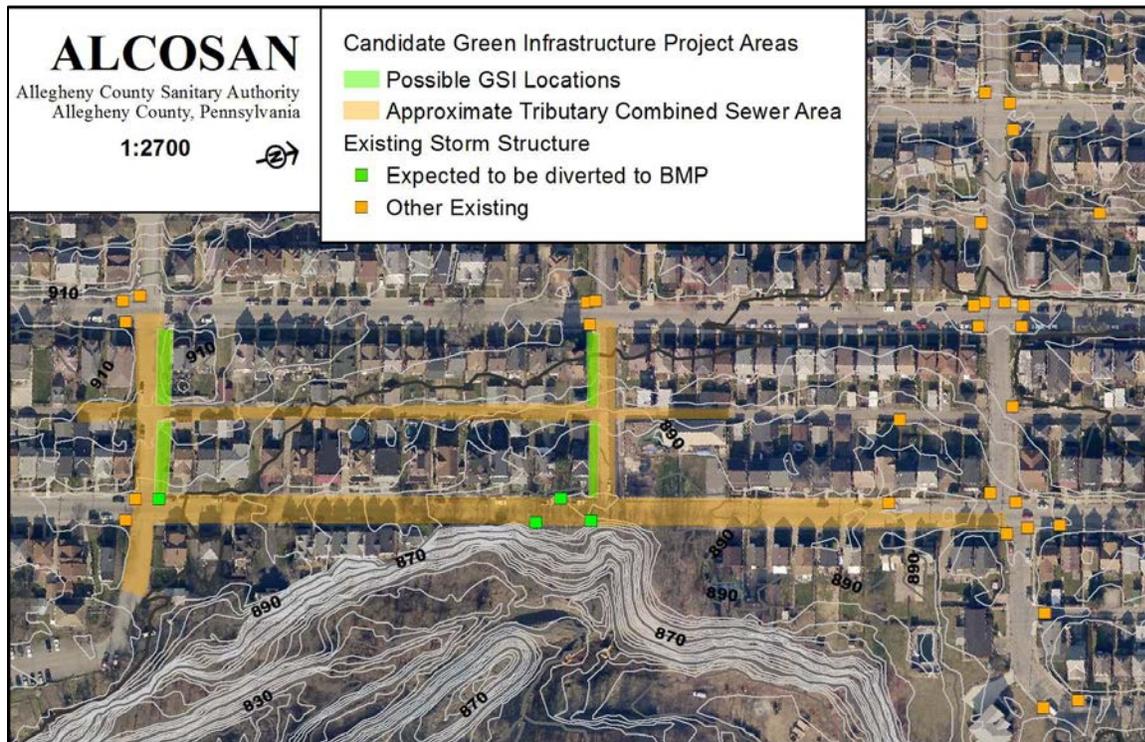
Potential Green Infrastructure Project Site
Site 13 – Chislett Street upstream of Heths Run
City of Pittsburgh, Morningside Neighborhood

Curb Condition
 Curb is in good condition along Chislett. There is little to no curb along Vetter Vilsack and Bryant.

Sidewalk / Street Trees / Other ROW Landscaping
 The sidewalk is in good condition. There are very few areas where it is damaged/cracked. There are a few locations where mature trees exist in the public ROW. Street trees are more common on the eastern side of Chislett.

One group of projects would be to install infiltration trenches/rain gardens within the public ROW along Vetter, Vilsack and Bryant. The existing grassy areas in the public ROW could be retrofit to capture stormwater flowing toward Heths Run. Another opportunity would be to modify existing inlets and route stormwater through a channel into the ravine at the intersection of Vetter St and Chislett St. The existing ravine could be used to channel stormwater into a GI feature within Heths Run. This project could be ancillary to the on going restoration plans for Heths Run.
