Starting at the Source:
How Our Region Can Work Together for Clean Water

Appendix H - Project Location Site Summaries

Appendix E-8 – Project Location Site Summaries

Green Stormwater Infrastructure Field Evaluation (Part 1)

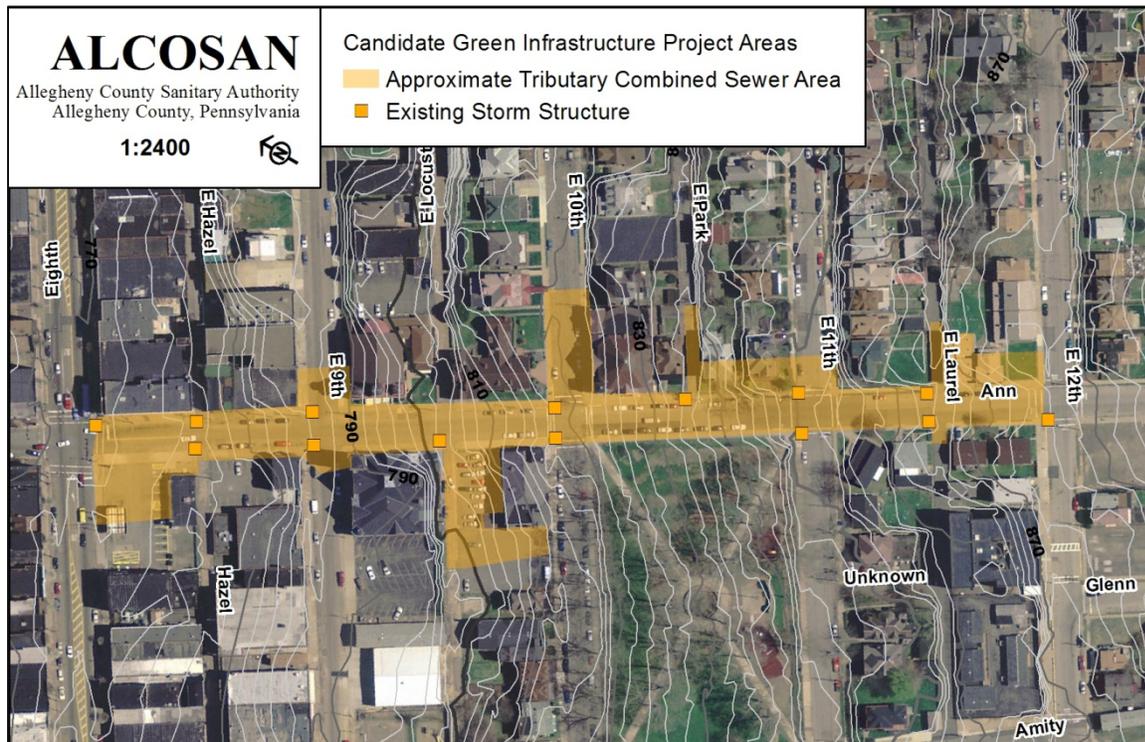
Potential Green Infrastructure Project Site
Site 59 - Ann Street between E 8th Avenue and E 12th Avenue
Homestead Borough

Areas of low and deteriorating curb, Ann between 9th and 10th, west side. Rest of area has relatively good to excellent curb condition and frontage along Ann St.

Potential GI Project: Construct bioretention/infiltration bumpouts in existing street parking areas and/or sidewalk upstream of 13 catch basins and one inlet structure along Ann Street. There is also potential to reroute stormwater runoff into an infiltration area along Frick Park between 10th and 11th Avenue.

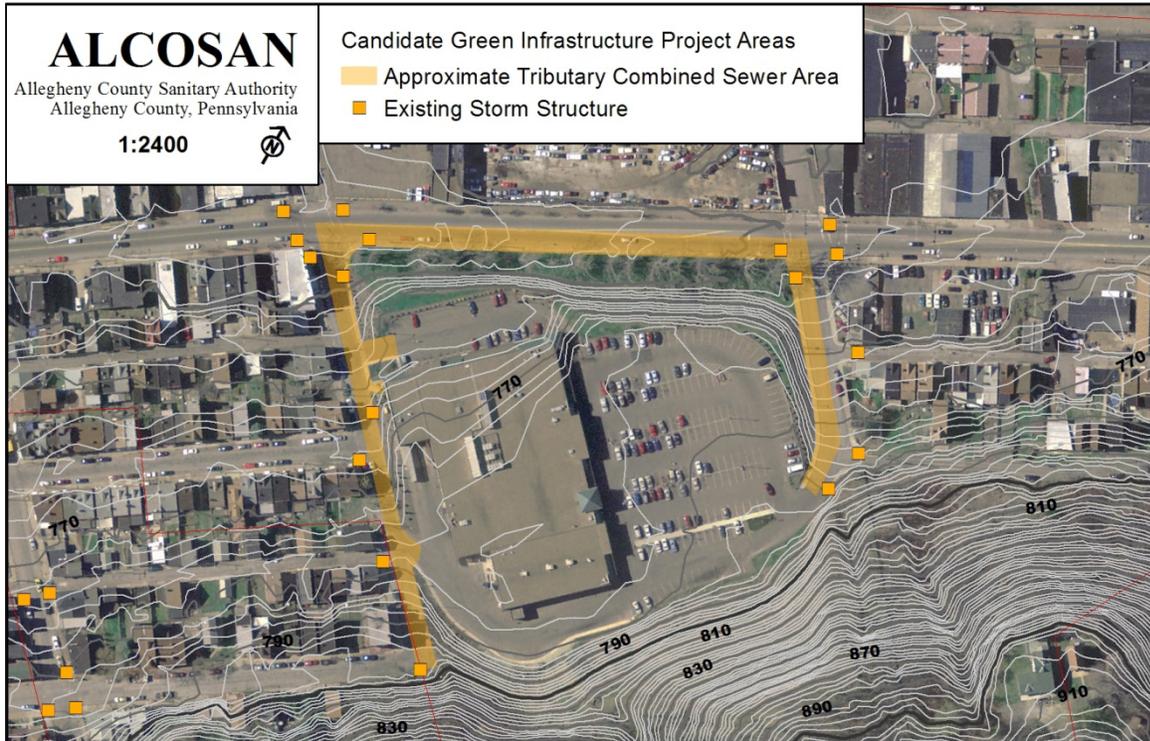
Potential Green Infrastructure Project Site
Site 34 - Upper Lawrenceville Shopping Center
City of Pittsburgh, Lawrenceville Neighborhood

Low curb on the both sides of Butler St. Some deteriorated and low curb along 55th street.

Significant slope along both 55th and 56th Streets as well, some erosion and sediment buildup due to runoff noticed. Erosion from runoff seen at 56th and Carnegie; special catch basin configuration on private property observed. Bike traffic on Butler Street may be part of longer term plans for City as bike infrastructure has been a priority in recent Bloomfield/Lawrenceville redevelopments.

Potential GI Project: Right-of-way space along Butler Street, 55th and 56th Streets could serve as a bioretention/infiltration swales to collect runoff from streets and sidewalks along Butler, 55th and 56th. Coordination needed with property owner for parallel opportunities to build GI on private land to capture runoff from tributary private impervious area.

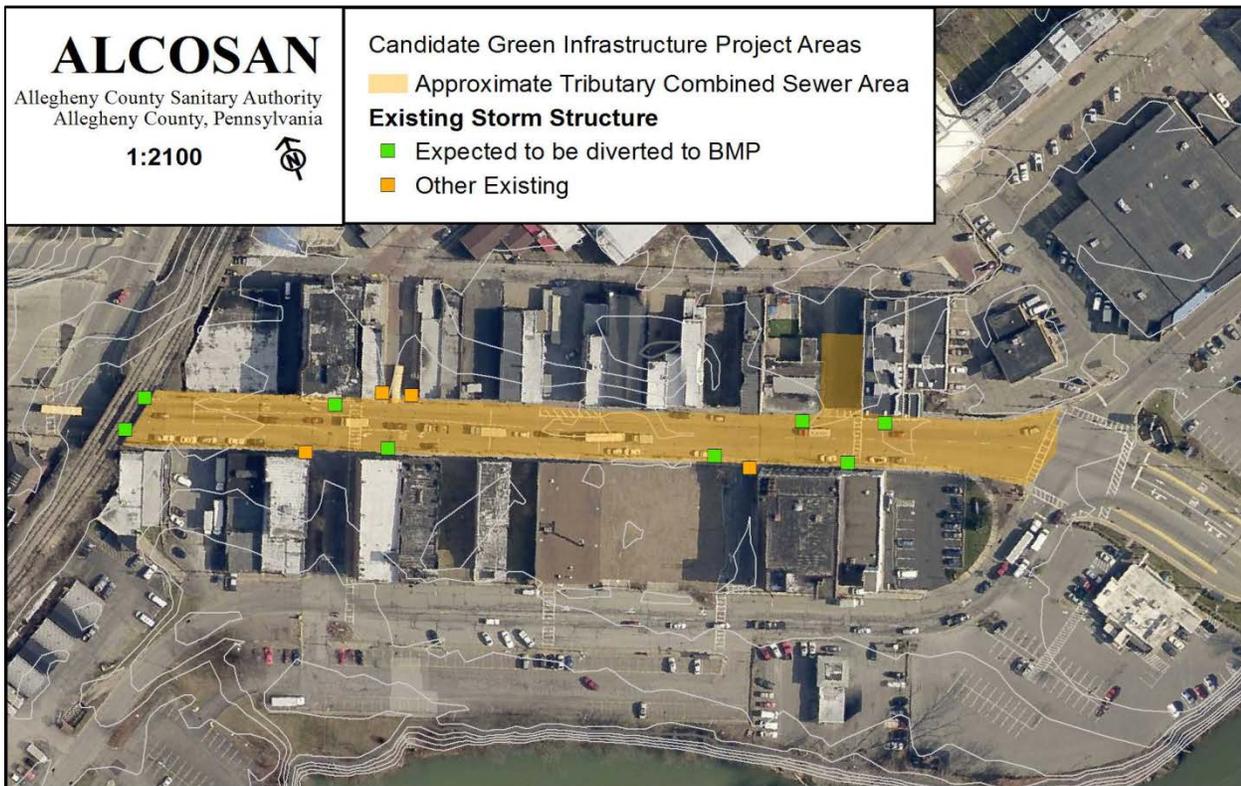
Potential Green Infrastructure Project Site
Site 39 – Chartiers Ave
Mckees Rocks

Curb appears to be in good condition

Potential GI Project: Potential to construct bioretention/infiltration bumpouts and/or swales in the public right-of-way upstream of catch basin next to WPA Conservancy landscaping.

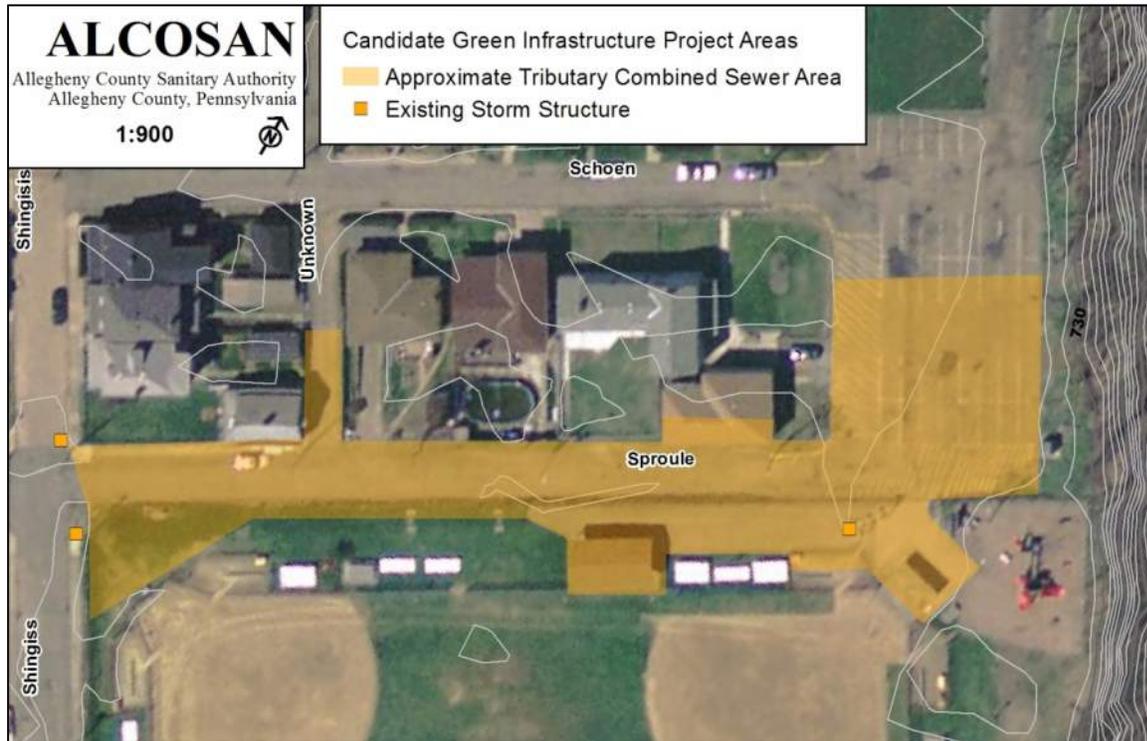
Potential Green Infrastructure Project Site
Site 129 - Sproul Street
McKees Rocks Borough

There are two catch basins at the eastern side of the intersection of Sproul and Shingiss Street which currently collect the runoff from Sproul. Additional catch basin is located within park, as noted on map. Extend of ponding issues noted from discussion and photos shared by nearby resident.

Curb to be part of reconstruction. Existing curb is in fair to poor condition on both sides of Sproul.

Potential GI Project: Borough-initiated project idea to incorporate GI within municipal-owned Rangers Park to collect runoff from entire width of Sproul Street and portion of adjacent parking lot for park. Part of a road reconstruction of Sproul Street, Borough has shared preliminary concept with ALCOSAN.

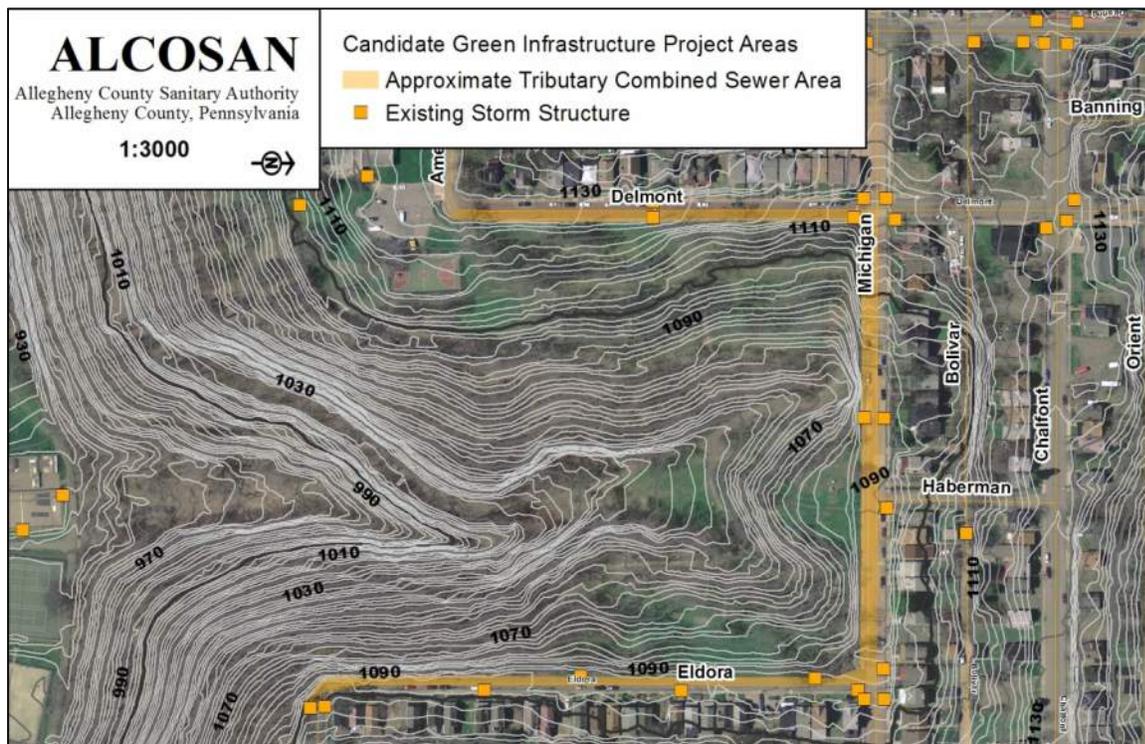
Potential Green Infrastructure Project Site
Site 83 – Delmont Ave, Michigan St, and Eldora Place along McKinley Park
City of Pittsburgh, Beltzhoover Neighborhood

Inlet on northern corner of Michigan and Delmont is collapsing. Sediment deposits at the low point of Michigan St. Inlet on western side of Eldora bordering McKinley Park in poor condition. Inlet on corner of Michigan St and Haberman Ave in poor condition.

No curb existing along western side of Eldora. Curb reveal seems adequate on other roads. Curbs in good condition, however street sweeping does not seem to occur regularly due to sediment deposits and litter on street.

Haberman Ave is a steep slope and potentially drains significant water onto Michigan in front of McKinley Park. Erosion likely caused by runoff from Haberman into park noted in photos. Sidewalk in the area of the two inlets of Michigan is being eroded by apparent heavy flow into the park. Overall drainage of park runoff into hillside is unknown, has been investigated by ALCOSAN. Illegal dumping an existing issue within park.

Potential GI Project: Opportunities to reroute stormwater via curb cuts along Delmont Ave, Michigan Street and Eldora Place to GI retrofit installations within McKinley Park and/or public right-of-way.

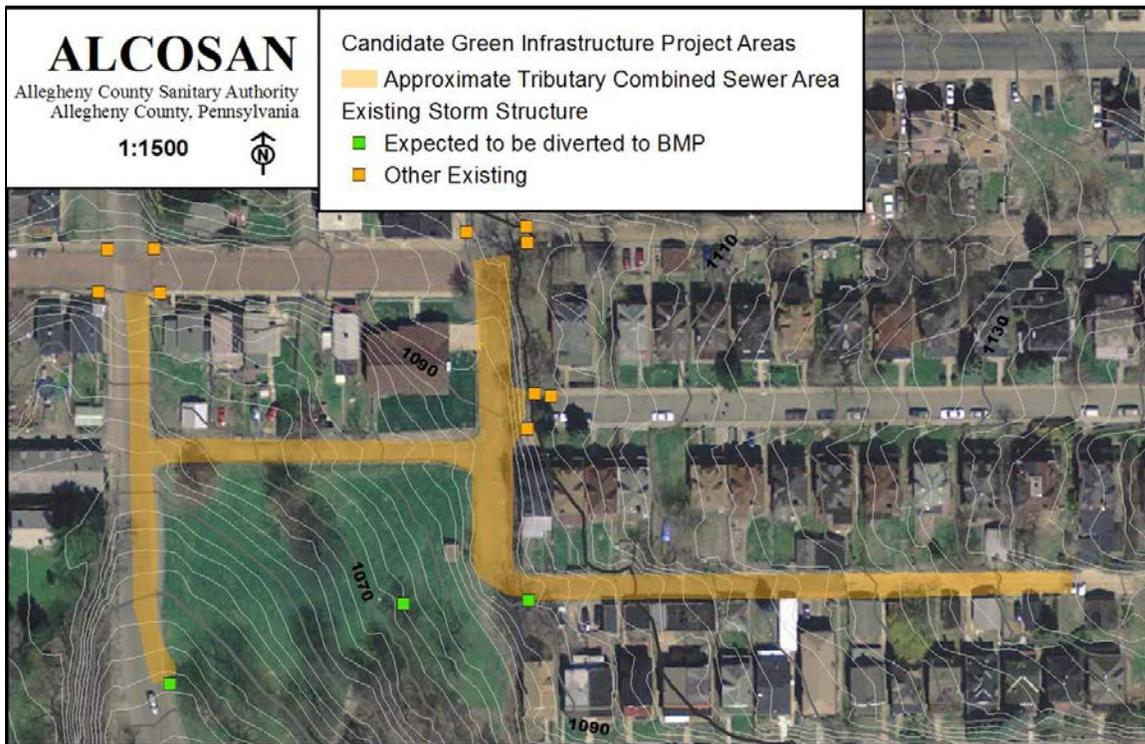
Potential Green Infrastructure Project Site
Site 167 - Zelda Way and Bernd St along McKinley Park
City of Pittsburgh, Beltzhoover Neighborhood

Triangle shaped lot bound by Bernd St, Zelda Way and Beltzhoover Ave. Area is part of McKinley Park. There is some pump house or small structure located near Beltzhoover Ave within the park limits. There is a small degraded set of stairs leading into the park area on the corner of Beltzhoover Ave and Elsinburg Way.

Potential GI Project: Opportunities to reroute stormwater into the existing green space. GI feature along Bernd to capture flow from Zelda and off of Bernd upstream of the catchbasin. Other GI features on the eastern side of the site could be used to capture flow from Elsinburgh Way & Beltzhoover Ave.

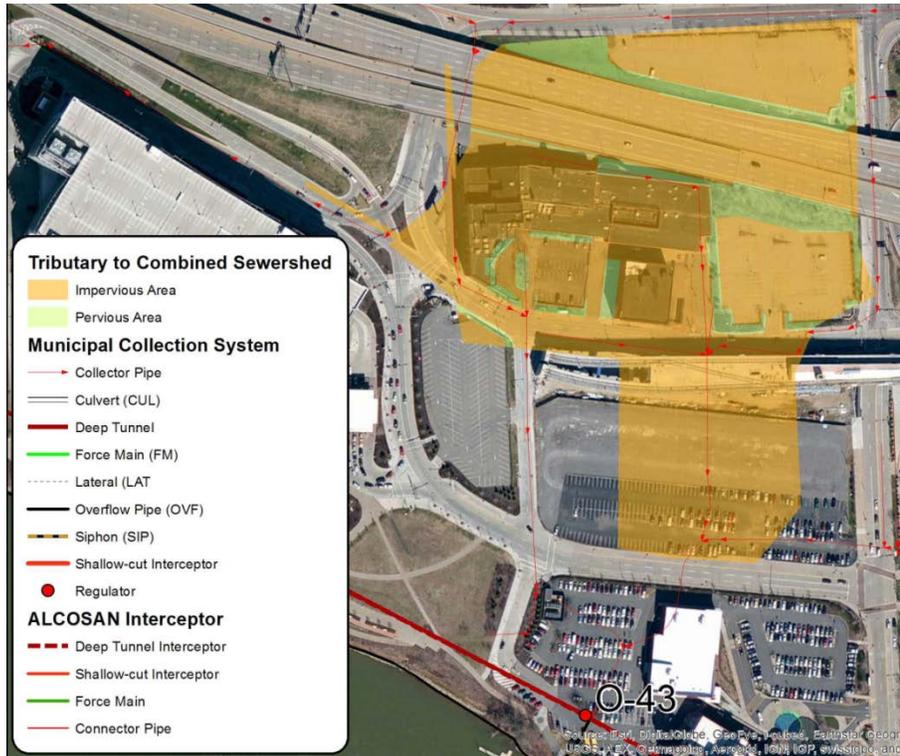
**Potential Green Infrastructure Project Site
Site 163 - O-43 Sewershed
City of Pittsburgh, Chateau Neighborhood**

Boyce Street is a degraded brick road with no apparent drainage.

Ample curb throughout most of the area. Lower curb below the Allegheny station to allow bus traffic in and out of the area. Sections of curb missing in front of 1000 Reedsdale Street.

Potential GI Project: O-43 is a sewershed where green infrastructure could be cost-competitive with proposed grey infrastructure. GI would be placed at strategic locations throughout the sewershed, with an initial focus of rerouting existing parking lot runoff to an existing green space between the Rivers Casino and Carnegie Science Center.

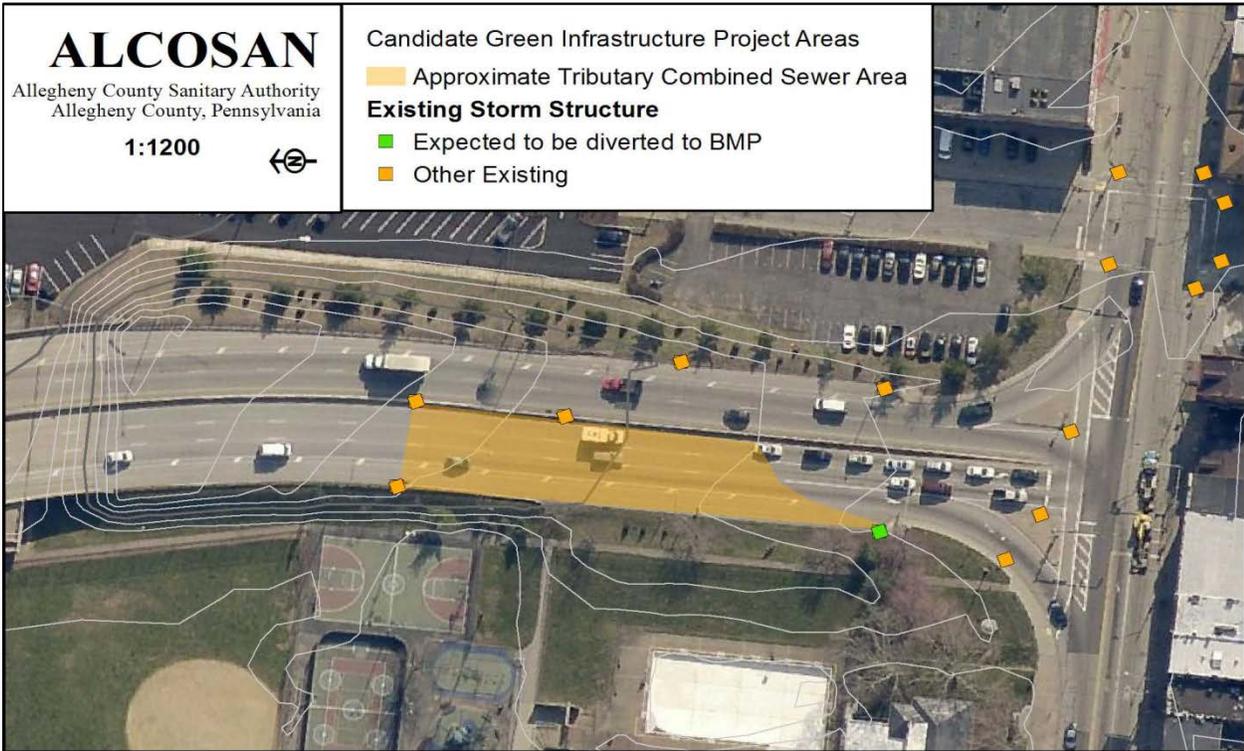
Potential Green Infrastructure Project Site
Site 28 - Birmingham Bridge adjacent to Ormsby Park
City of Pittsburgh, Southside Neighborhood

Curb has ample reveal and is in good condition.

Basketball court is degraded and drains to a catch basin on the pedestrian path. Steep grassy area from bridge sloped down to public park.

Potential GI Project: Potential to reroute runoff from Birmingham Bridge off-ramp to existing lawn area adjacent to Ormsby Park. Project has similar potential on other side of bridge with adjacent private property and could also be integrated within planned PennDOT traffic calming and pedestrian safety project along East Carson Street.

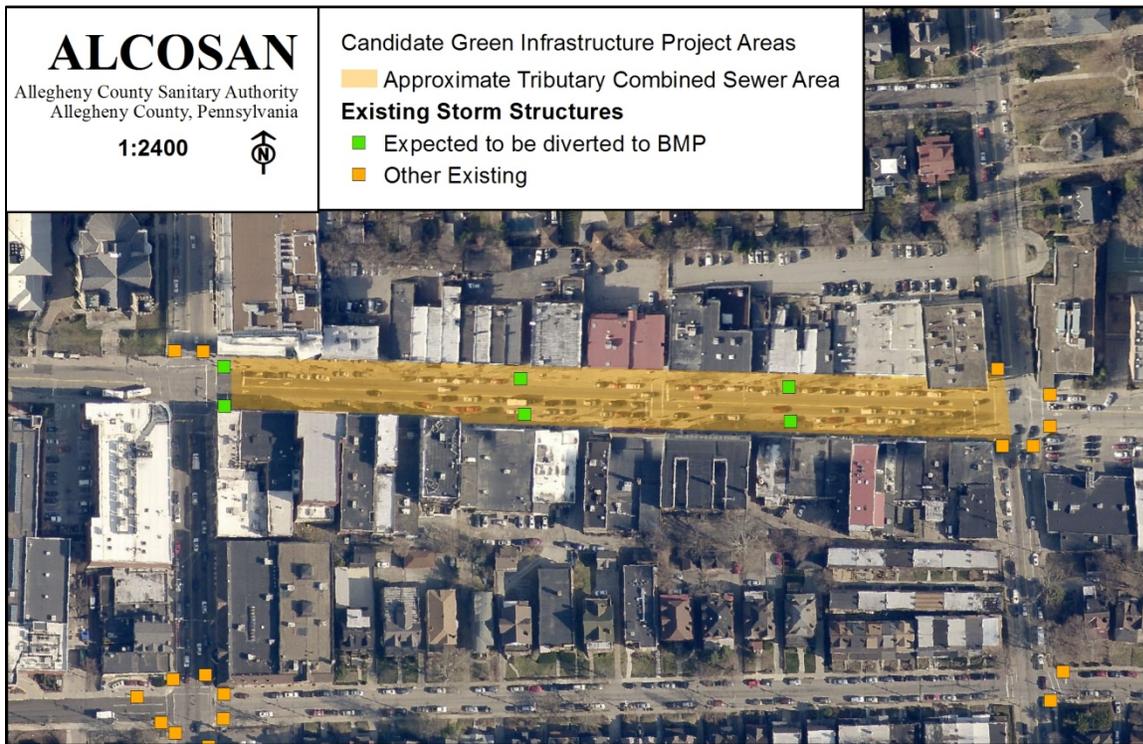
Potential Green Infrastructure Project Site
Site 8 - Forbes Avenue Business District between Murray and Shady Avenue
City of Pittsburgh, Squirrel Hill Neighborhood

The curb is in good condition. The area is well maintained.

Potential GI Project: Opportunities to construct bioretention/infiltration trench around existing street trees on Forbes Avenue Business District. A pedestrian crossing in the middle of Forbes Ave offers opportunities for a GI bumpout to enhance pedestrian safety.

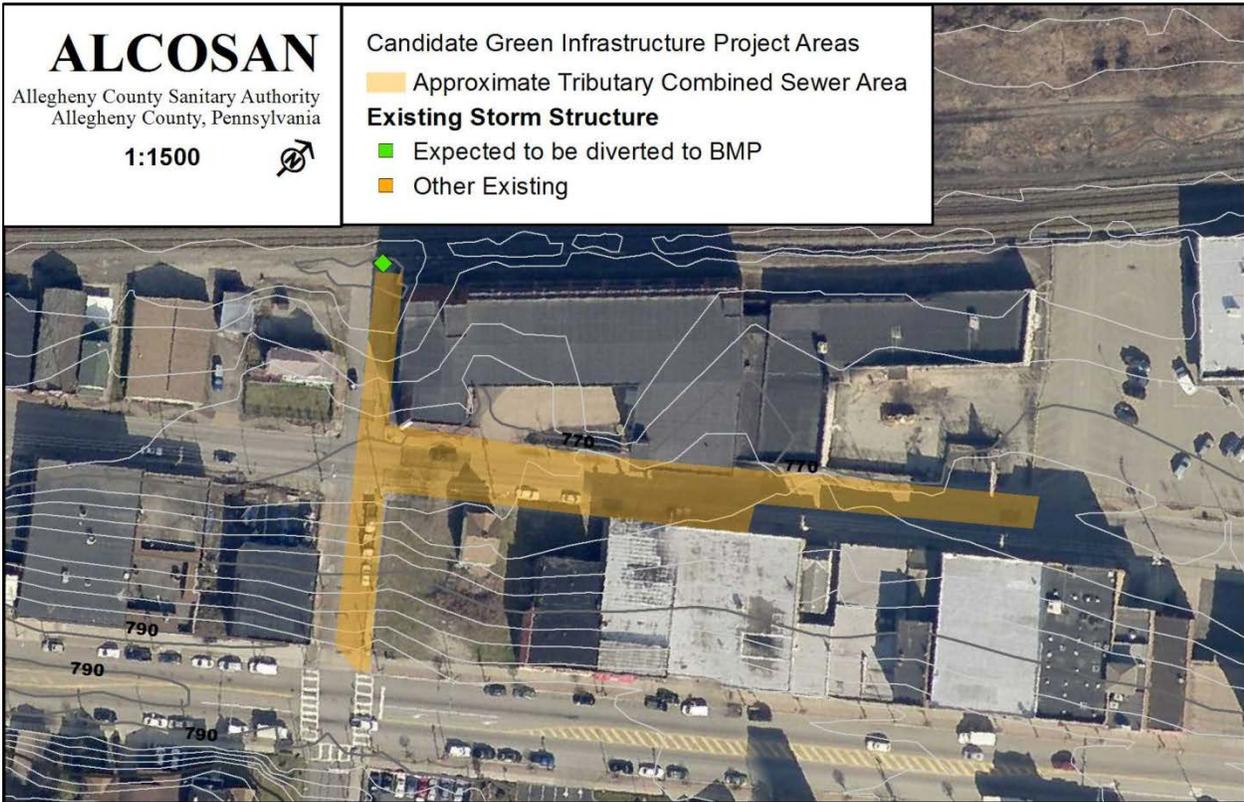
Potential Green Infrastructure Project Site
Site 71 - 7th Avenue, Site of Former Keystone Plumbing
West Homestead Borough

Opportunity to modify existing street trees to capture storm water. Degraded sidewalk along Neel St could be another potential site to have a bioretention area. Any GI on Neel would need to maintain existing loading dock. Basin at the bottom of Neel could be tied into if a bioretention feature was constructed.

Potential GI Project: Program for Offenders is reconstructing the former Keystone Plumbing site. There is potential to modify existing street trees via curb cuts along 7th Ave. GI opportunities also exist along Neel Street within the sidewalk adjacent to the Keystone Site.

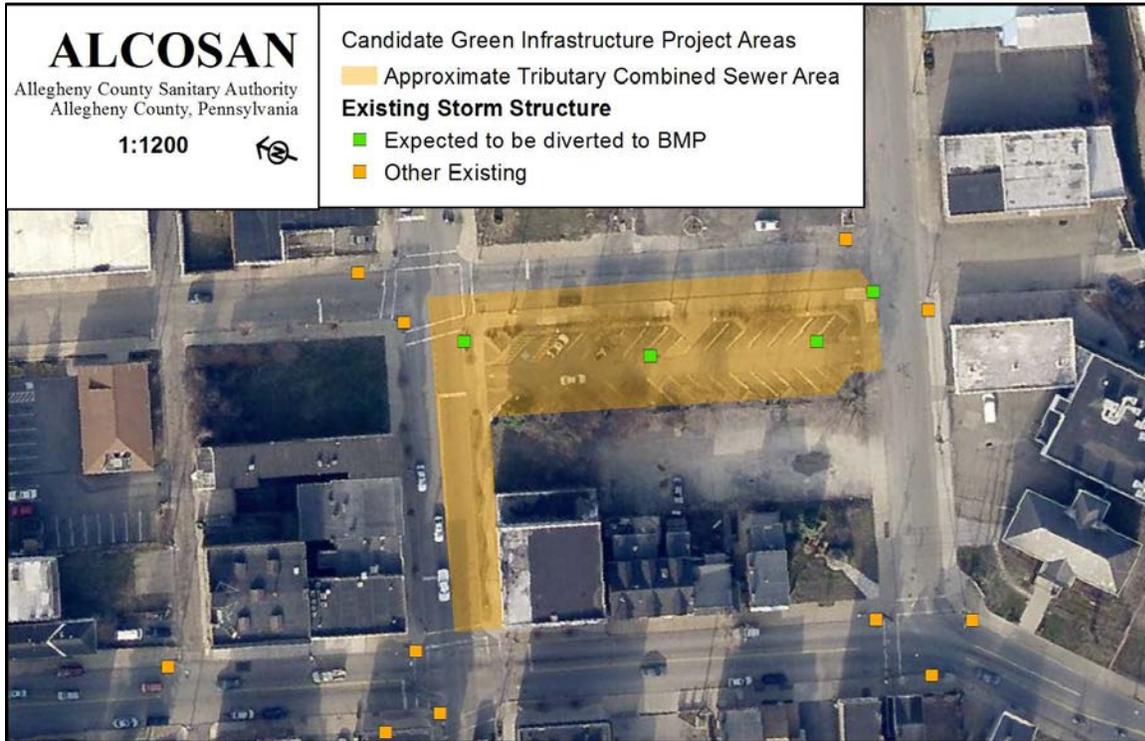
**Potential Green Infrastructure Project Site
Site 137 -Parking Lot at Main Street and Alexander
City of Pittsburgh, West End Neighborhood**

There is potential to construct two GI installations at the corners of Alexander & Main, and Alexander & Neptune. A curb cut and trench would need to be constructed to take runoff from Main upstream of the basin on the corner of Alexander & Main. The corner is a natural low spot where there is evidence of water ponding. This location would be adjacent to the entrance to the lot and help beautify the corner of Main and Alexander. The other GI location would most likely require the elimination of one parking spot to provide adequate space to capture runoff. Runoff can be captured from both within the lot and along Alexander St if the curb were cut to allow flow to travel to the retention area.

Potential GI Project: Potential to construct bioretention/infiltration bumpouts and/or swales within the existing parking lot and perimeter sidewalk. Parking lot runoff could be maintained with modifications to on-site catch basins and conversion of one or more parking spaces into a GI feature. Additional green infrastructure could be retrofit into existing sidewalk landscaping to capture runoff from Main Street.
